INJURY FROM METAL FRAGMENT

This very serious injury happened on one of our sites.

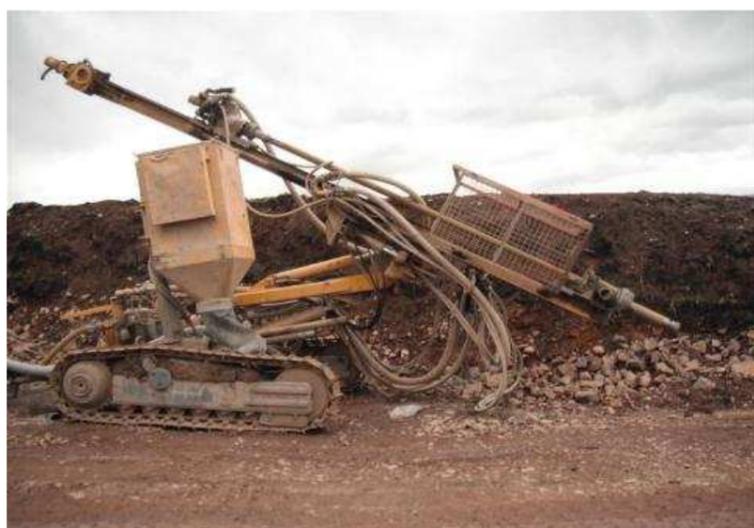
A drilling rig was being used at a borrow pit to drill holes in preparation for blasting. The drill bit needed to be replaced and the Sub-Contractor's Plant Fitter came to site to undertake the replacement.

To facilitate easy access to the drill bit, the drilling rig arm was placed in the horizontal position.

Drilling Rig used at Borrow Pit

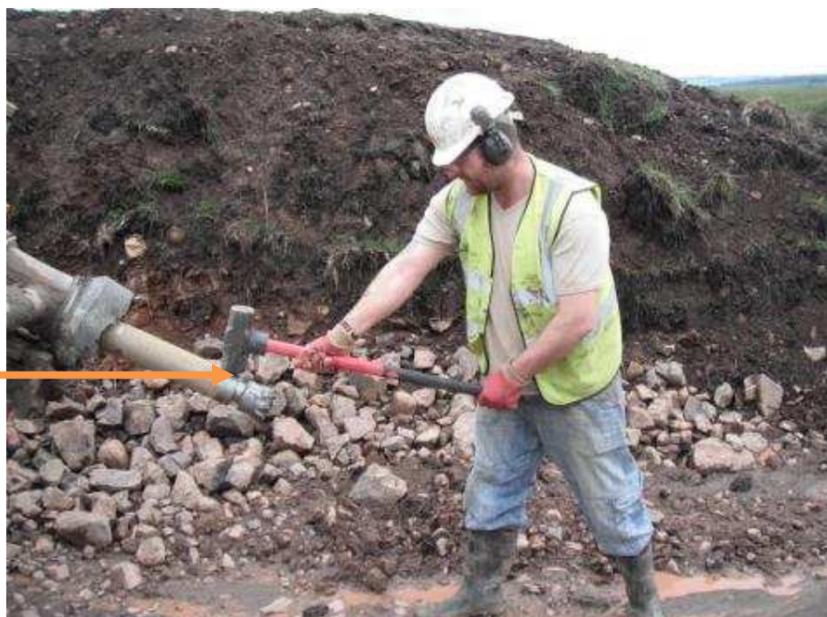
The drill bit was held in place by a metal 'chuck'. The 'chuck' had to be unscrewed to release the drill bit. This proved to be difficult and the Plant Fitter used a sledge hammer to release the 'chuck' from the threaded connection.

Sledge hammer used to loosen threaded joint of 'chuck'

- 1. It is dangerous to strike metal castings with tools such as hammers. As seen from this accident, this type of metal can break.**
- 2. Maintenance personnel need to have risk assessments and a method statement / safe system of work for undertaking maintenance on site.**
- 3. The manufacturer's recommendations for removing a drill bit of this type clearly states 'Never Use a Sledge-Hammer on Down-the-Hole Hammers'. There is a special tool for the job.**

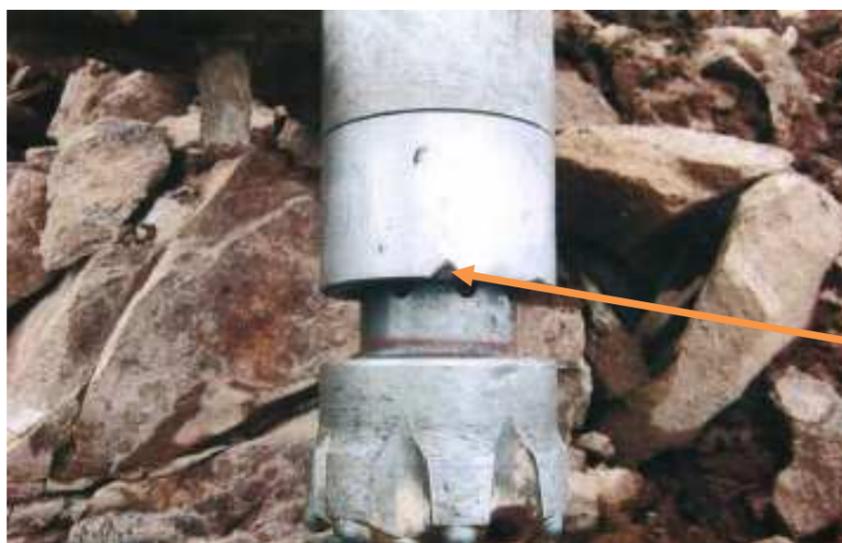
An operative, also employed by the Sub-Contractor, was standing approximately 12m away. Whilst the 'chuck' was being struck by the sledge hammer, a small piece of metal broke free, and travelling horizontally, hit the operative in the stomach. The operative was taken to hospital and underwent an operation to have the fragment of metal removed.

Piece of metal broken from 'chuck'
