INCIDENT ALERT

| LOCATION: | QUARRY | ALERT STATUS: | Normal |

Fatal 1 - LOTOTO failure of an isolator

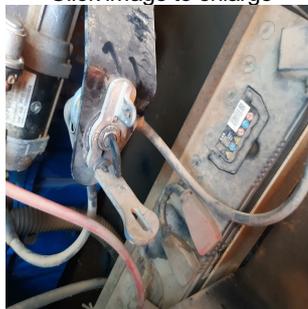
The generator set was fitted with a battery isolator switch shown in the attached image. The purpose of the isolator is to isolate power from the battery to the starter motor of the generator set as a means of achieving secure isolation during maintenance, for example.

The investigation showed that the barrel of the lock was worn and it was possible to remove the key in the **ON** position. In fact, the key was so loose in the lock barrel that vibration had caused it to fall out.

The failure created a hazardous situation where the key could be removed from the isolator without isolating power from the battery. An operator may lock the flap in position believing that the battery is isolated when in fact it isn't. Isolation has not been achieved and the safety of operatives working on the plant is then entirely dependent on the final **TRY OUT** step of **LOTOTO** to reveal the defect.

- Immediate action was taken to replace the worn battery isolator switch lock barrel.

- Operators of similar plant and equipment are advised to review their isolation procedures to ensure that their **LOTOTO** procedure includes isolating power at the battery to prevent any risk of the plant starting during maintenance activities.
- High integrity switched battery isolators or lockable battery terminal bags or boxes are available and should be used and form part of the **LOTOTO** procedure.
- Isolators are safety critical and should be included in a scheme of examination and maintained as necessary.
- Plant operators should have sufficient training and competence to be able to identify dangerous situations and understand the importance of reporting them as well as knowing how to report them so that they can be remedied.
